REDISTRIBUTION OF CARBON IN STEELS DURING LONG-TERM OPERATION OF EQUIPMENT IN HYDROGEN-CONTAINING ENVIRONMENTS

The effect of carbon redistribution during long-term operation of equipment operating in different hydrogenating environments and at different operating pressures is described. It was revealed that microstructural decarburization in damaged equipment was caused by carbon diffusion from the pearlite grain body and its accumulation along the grain boundaries. In this case, the average concentration of carbon did not change. This effect was confirmed by a complex of tests: optical emission analysis, optical and electron microscopy, energy-dispersive analysis of the structural components on polished metallographic sections, elemental mapping of surfaces obtained as a result of impact tests of the analyzed samples. It is shown that the pattern of the diffusive redistribution of carbon did not depend on the composition of the working medium (organic and inorganic substances and their mixtures), but resulted from industrial equipment operation time under external load.

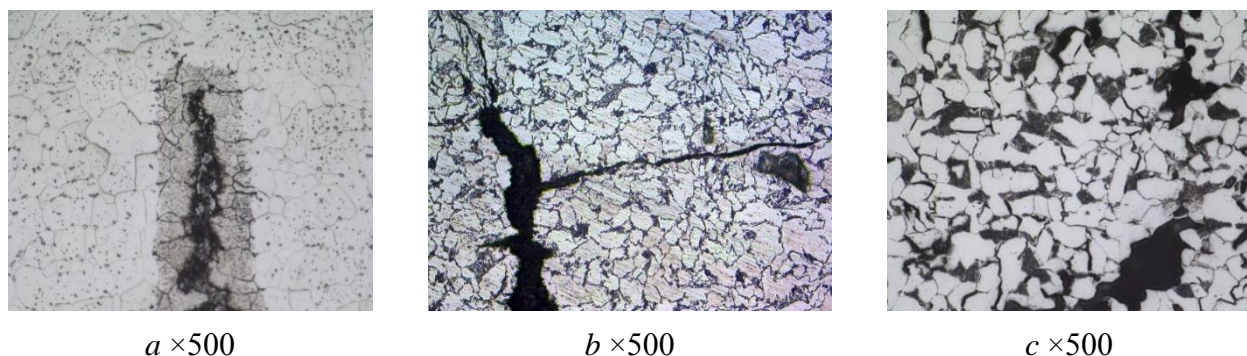
Metallographic analysis showed that, during operation, decarburization of the internal structure of steel grains with varying degrees of intensity occurred under the influence of hydrogen. In sample No 1D the microstructure of the sample near the site of destruction of the reactor walls consists of almost pure ferrite (Fig. 1 *a*), carbides being disintegrated completely. In samples No 2D (Fig. 1 *b*) and No 3D (Fig. 1 *c*) only partial decarburization of the microstructure occurred. The decay of the carbide component of the steel within the boundaries of the former pearlite grains is clearly visible in these samples.

Fig. 1. The microstructures of the samples near the damage: sample No 1D (*a*); sample No 2D (*b*); sample No 3D (*c*)

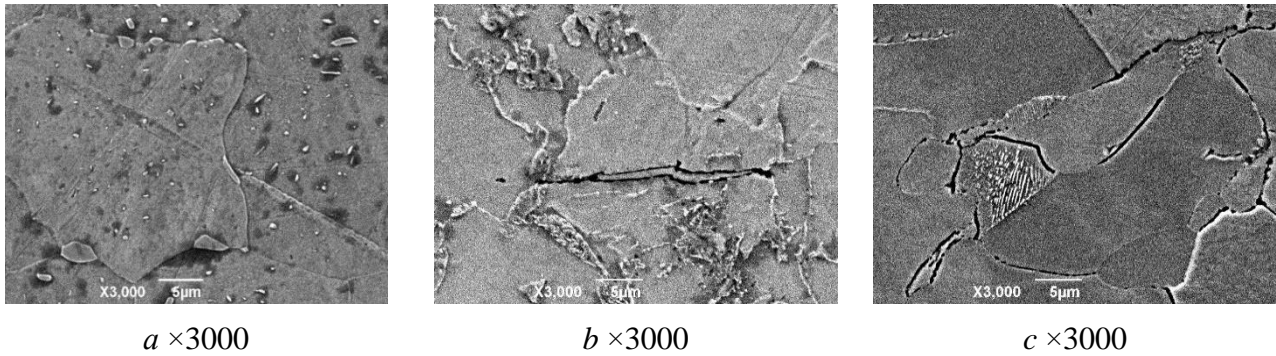
All the metal underwent the same phase changes during operation. There is no difference between carbon distribution along the edges of the fractures and that at a distance from them. In sample No 1D microcracks and cracking around these cracks are present, at a distance from the damage ($\square 100$ mm), cracking along grain boundaries was not detected (Fig. 2 *a*). Cracking was detected at a distance from the damage in samples No 2D (Fig. 2 *b*) and No 3D (Fig. 2 *c*). It is more intensive in sample No 3D.

As is known [1, 14, 15], when steels are saturated with hydrogen, the latter interacts with cementite to form methane gas, and this should lead to the formation of voids along the grain boundaries and the swelling of the metal. In the samples studied by us, metal swelling and the formation of voids along the grain boundaries due to damage accumulation and accumulation of methane were not detected. The width of the intergranular cracks in all the samples after operation was the same (Fig. 2 *b, c*).

Fig. 2. The microstructures of the damaged samples at a distance from the damage: sample No 1D (a); sample No 2D (b); sample No 3D (c)

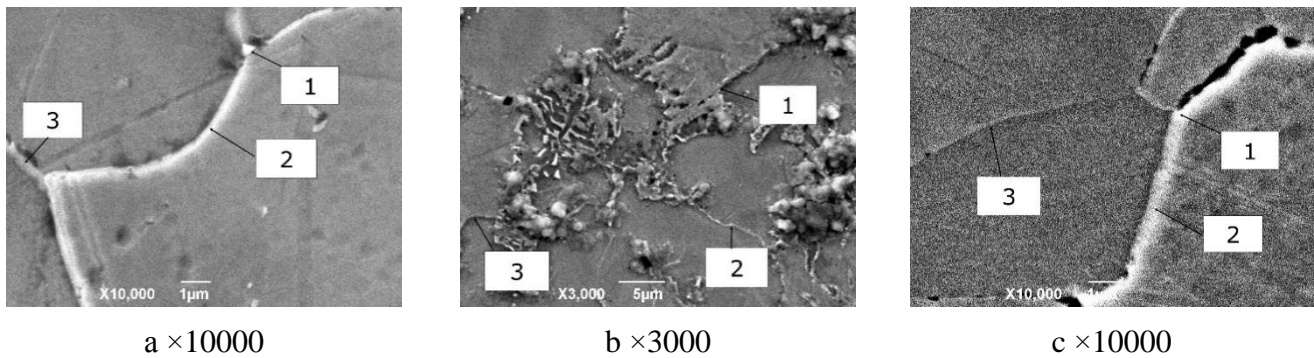
Fig. 3. Electron microscopic images of the metal samples transmitted in secondary electrons, indicating the locations of EDS analysis: sample No 1D (a); sample No 2D (b); sample No 3D (c)

According to the above photos and the data of Table 4, it can be seen that, during operation of the equipment, carbon atoms diffused from pearlite to grain boundaries. The maximum carbon concentration was recorded by us along the boundary of three grains, and it was 11.5, 9.0, and 9.9% for samples Nos 1D, 2D, and 3D, respectively. The concentrations obtained correlate with the microstructural studies, where the degree of grain decarburization was maximal in sample No 1D.

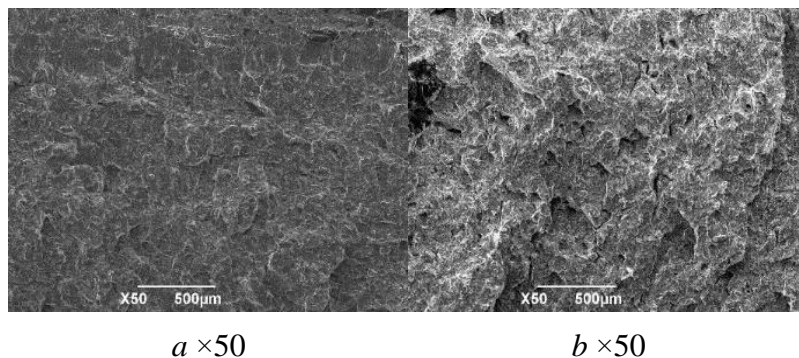
The elemental mapping of the surfaces was carried out in the center of the fractures in 5 areas. The electron microscopic images of the surfaces of samples No 1D and No 1N are shown in Fig. 4. The values of carbon concentration in the analyzed fields are shown in Table 5. A good convergence in carbon concentration at different control sites within the same sample was obtained. With

the initial equality in the carbon concentration in new and damaged samples No 1, the carbon concentration on the fracture surface in the damaged samples is 2.5 times as high. Similar results were obtained when comparing the results of the analysis of the fractures in damaged and new samples No 2 and No 3, where the carbon concentration along the grain boundaries in the damaged equipment exceeded that in the new samples for certain.

Fig. 4. Electron microscopic images of sample fractures after impact bending: sample No 1D (a); sample No 1N (b)
