**STRUCTURE AND FATIGUE DURABILITY OF 09Mn2Si PIPE STEEL
 AFTER LONG-TERM OPERATION IN FAR NORTH CONDITIONS**

A comprehensive study of the structure and fatigue durability of the 09Mn2Si steel used for constructing the Mastakh-Berge-Yakutsk main gas pipeline (taken from the linear part with an outer diameter of 530 mm and a wall thickness of 7mm) after 37 years of operation is carried out. A comparative analysis of the results obtained for the emergency stock steel is made. It is shown that long-term operation does not give rise to a substantial redistribution of cementite. Deformation aging is slightly expressed, and it is manifested through the precipitation of finely dispersed carbides in the grain bulk. The revealed structure degradation practically does not make sense under static tension or hardness measurement. At the same time, under cyclic testing, the microstructure degradation occurring during long-term operation results in a fatigue lifetime decrease, especially at the stage of crack initiation.

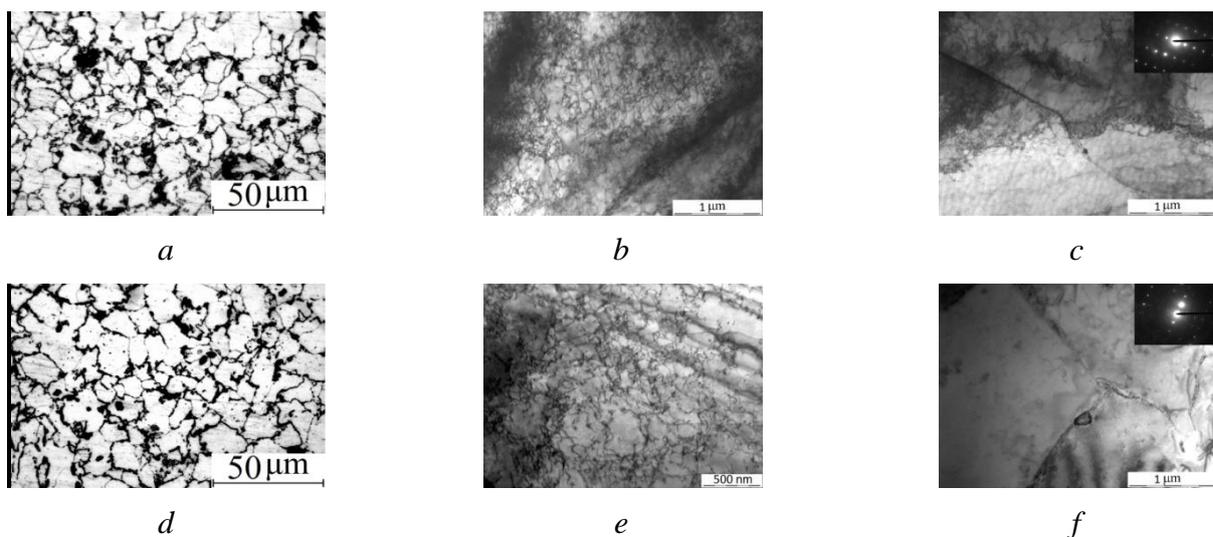
The steel from the emergency stock has a ferrite-pearlite structure (fig. 1, *a*). The pearlite content makes $\sim 16 \pm 1\%$; a pronounced striped texture is observed. The average grain size is equal to $9.5 \pm 1 \mu\text{m}$. The steel after 37 years of operation also has a ferrite-pearlite structure. The pearlite content makes $\sim 12 \pm 0.6 \%$; the pearlitic colonies are small, and they are located mainly along the grain boundaries (fig. 1, *d*). The average grain size of this fragment is equal to $11 \pm 1 \mu\text{m}$. Thus, during operation, the content of the pearlite phase in the 09Mn2Si steel has decreased by $\sim 5 \%$. It is may have come from hydrogenation, as a result of prolonged exposure to a gaseous medium. The decrease in the carbon content is also accompanied by a slight increase in the size of ferritic grains (by $\sim 10 \%$).

Fig. 1. The microstructure (*a, d*) and TEM-micrographs (*b, c, e, f*) of steel fragments from the emergency reserve (*a, b, c*) and after long-term operation (*d, e, f*)

In the material bulk of both steel fragments, a ferrite structure with cementite plates along the grain boundaries is observed by transmission electron microscopy. Large uniaxial cementite particles (100–500 nm) are located both in the grain bodies and along the grain boundaries (fig. 1, *c, f*). The dislocation density for the stock steel is higher, 10^{10} to 10^{11} cm⁻², while after the operation it is 10^9 to 10^{10} cm⁻² (fig. 1, *b, e*). It is known from the literature [1] that long-term operation of steel may give rise both to already mentioned hydrogenation and to structural degradation processes expressed through deformation and crushing of cementite along the boundaries of ferrite grains, the formation of carbide precipitates there, as well as through the evolution of the dislocation substructure due to deformation aging.

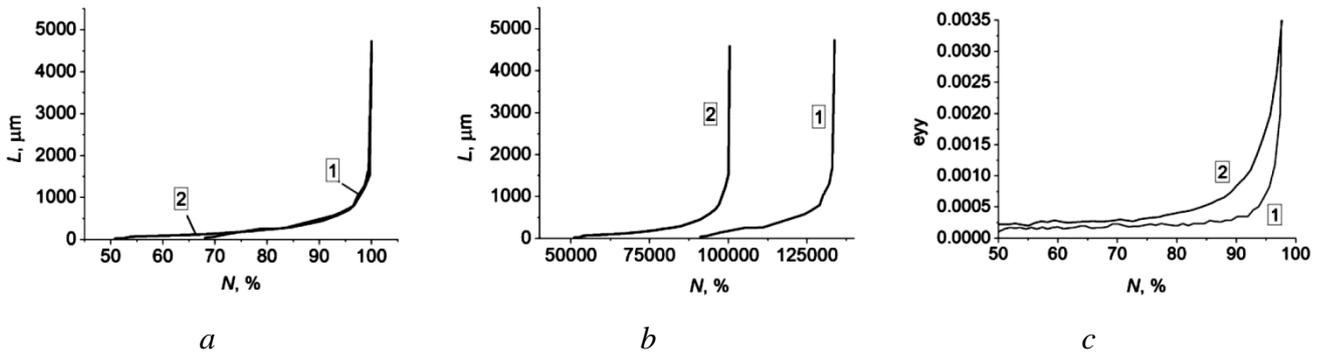
The fatigue lifetime of the 09Mn2Si steel after long-time operation decreases by 16 %, from $N = 1.25 \times 10^5 \pm 0.16 \times 10^5$ (emergency reserve) to $N = 1.05 \times 10^5 \pm 0.18 \times 10^5$ cycles (after operation). Graphs illustrating the dependence of crack length versus the number of loading cycles are plotted in fig. 2.

Fig. 2. Diagrams of fatigue crack growth versus *a*) the normalized number of cycles, *b*) the absolute number of cycles; *c*) dependences of longitudinal strain on cyclic loading (in percent prior to failure); 1 – emergency stock; 2 – after long-term use

It follows from the analysis of the data given in normalized coordinates (fig. 2, *a*) that crack propagation looks similar (although in the reserve stock material the crack nucleates later (for comparison $N_{I\text{oper}} \sim 50\%$ and $N_{I\text{res}} \sim 68\%$). The analysis of the crack growth diagrams plotted in the absolute coordinates (fig. 2, *b*) also shows that crack initiation in the emergency stock specimen occurs later. In general, in the specimens after operation the main fatigue crack originates earlier, while the plastic deformation accompanying the crack propagation is localized to a greater extent. This is confirmed by the graphs depicting the dependence of the longitudinal strain component versus the number of cycles prior to failure (the normalized value expressed in percent, fig. 2, *c*).

Thus, despite the shape similarity of the crack growth diagrams for the specimens of both types (when they are plotted in normalized coordinates (fig. 2, *a*, *b*)), it is the difference in the graphs of the transverse strain component that is the reason for the decrease in the fatigue life of the specimen after the long-term use. Namely, the exhaustion of plasticity does not allow the propagation of the main fatigue crack to be effectively resisted.
