INFLUENCE OF LONG-TERM OPERATION ON THE STRUCTURE AND IMPACT TOUGHNESS OF THE 09Mn2Si PIPE STEEL

The microstructure and mechanical properties of the 09Mn2Si steel used for construction of the Mastakh-Berge-Yakutsk natural gas transportation pipeline are investigated comprehensively after 37 years of operation. The results obtained for the specimens cut out from the pipe are compared to those obtained using emergency stock (reference) specimens. It is demonstrated that long-term operation in harsh climate does change the microstructure appreciably. Strain aging, however, can be identified through precipitation of finely dispersed carbides in the bulk grains, and hydrogen charging may occur in the steel, which gives rise to partial decarburization. The latter causes some embrittlement of the steel, measured under impact loading. The revealed microstructural changes do not practically affect static tension or hardness properties. This can be attributed to the development of two competing processes: i) softening as a result of decarburization and ii) hardening due to pinning of dislocations on carbide precipitates. The microstructure degradation results in sharp reduction of impact to

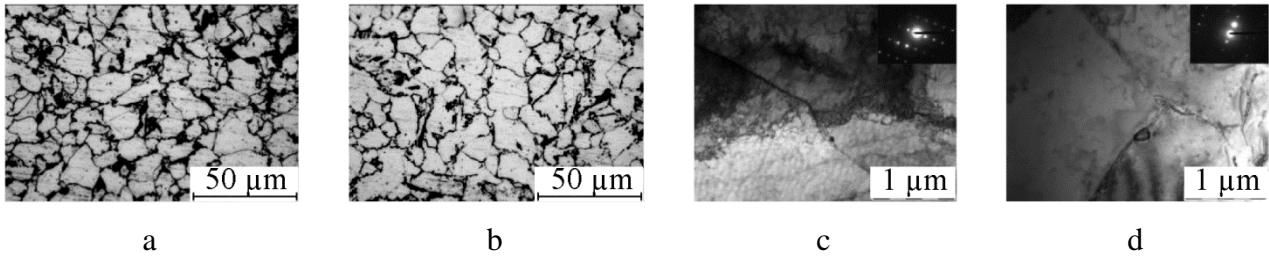
The measurement of pipe wall thickness for both types of steels has shown that 37 years of service result in an approximately 0.4 mm wall thickness reduction. The reference steel has a ferrite-pearlite structure, typical of hot-rolled sheets (Fig. 1 a). The pearlite content amounts to $16 \pm 1\%$. The average grain size is found to be $9.5 \pm 1 \text{ }\mu\text{m}$. The steel after use also possesses a ferrite-pearlite structure though the fraction of pearlite has reduced to about $12 \pm 0.6\%$; pearlite colonies appear to be small and located mainly along the grain boundaries (Fig. 1 b). The average grain size in this reference steel is equal to $11 \pm 1 \text{ }\mu\text{m}$.

Thus, during operation, the fraction of the pearlite phases in the 09Mn2Si steel decreases by $\sim 5\%$. The reasons responsible for these changes can be the influence of long-term exposure to a hydrogen-contacting medium. The reduction of the carbon content is also accompanied by a slight increase in the ferrite grain size (by $\sim 10\%$).

A typical ferrite structure with cementite plates along the grain boundaries in both examined steel fragments was observed with the help of transmission electron microscopy. Large equiaxial cementite particles (100 to 500 nm) are located both in the bulk grains and at the grain boundaries (Fig. 1 c). The dislocation density for the reference steel is higher, 10^{10} to 10^{11} cm^{-2} , while it is lower by an order of magnitude, i.e. 10^9 to 10^{10} cm^{-2} , after use (Fig. 1 d).

Fig. 1. Optical images of the microstructure of the 09Mn2Si steel (a, b); bright-field TEM micrographs (c, d); the reference material (a, c); the specimen after long-term operation (b, d)

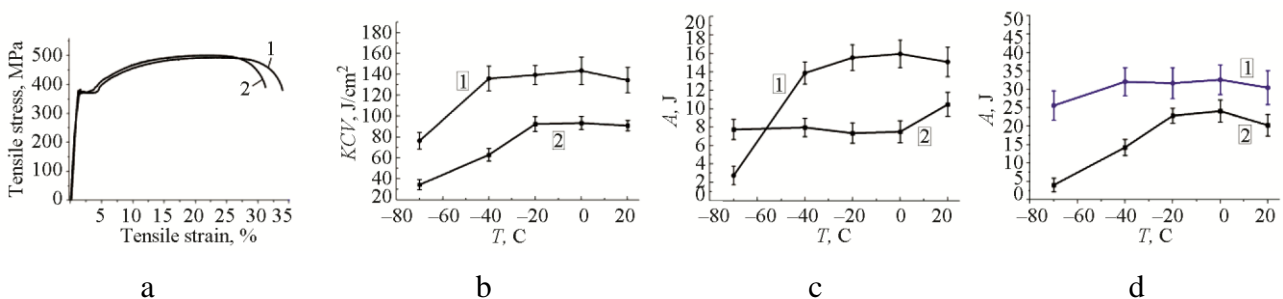
An upper yield point and the Lüders plateau are observed on the loading diagrams of the 09Mn2Si steel specimens in both states (Fig. 2 a). It agrees well with the results of TEM observations showing low dislocation density at the beginning of plastic flow [5]. Specimens of both types exhibit similar values of the lower and upper yield stresses and ultimate tensile strength. However, the reference specimens have appreciably higher ductility. This difference in ductility is likely to be due to a larger volume of the pearlite phase.

Fig. 2. Tensile diagrams for 09Mn2Si steel (a); impact toughness (b); energy of crack initiation (c); crack propagation energy vs. temperature (d): 1 – reference material; 2 – after long-term service

The impact toughness of the 09Mn2Si steel after many years of service under the cold climate conditions has decreased significantly in comparison with the reference steel for all the test temperatures (Fig. 2 b). The brittle-to-ductile transition for this steel starts at $T = -20$ °C, while it begins at a lower temperature, $T = -40$ °C, for the reference stock steel (Fig. 2 b). The increase in the brittle-to-ductile transition temperature in the steel after the service is caused by structural degradation accompanied by decarburization and strain hardening, as was noted above.

The mechanical energy for crack initiation and propagation has been estimated for the specimens of both types during impact testing (Fig. 2 c, d). The highest values of the mechanical energy A_I extended for the crack initiation stage are observed in the reference stock steel. The $A(T)$ curve drops sharply in the region of brittle-to-ductile transition, which is not seen for the steel after the service (Fig. 2 c). The energy of crack propagation for the reference steel is also higher (Fig. 2 d). However, unlike the initiation stage, a significant decrease in $A(T)$ is seen for both steels at the brittle-to-ductile transition.
